Pelletier Dam Removal and Engineering Design in Castleton, Vermont

THE VERMONT NATURAL RESOURCES COUNCIL (VNRC) retained Stone in 2018 to provide engineering and design services for the removal of the Pelletier Dam, located on North Breton Brook in Castleton. The Pelletier Dam was among several high-priority projects identified through the Vermont Dam Task Force—a collaborative effort led by the VNRC—to improve aquatic connectivity throughout the Lake Champlain watershed through the identification and removal of dams that no longer serve a useful purpose.

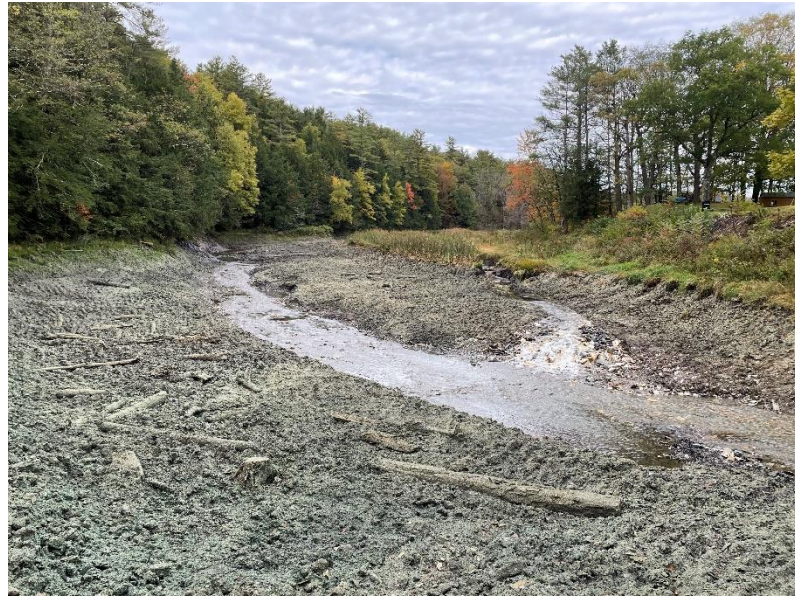
View from the former dam site upstream along the restored channel of North Breton Brook, Castleton, Vermont.

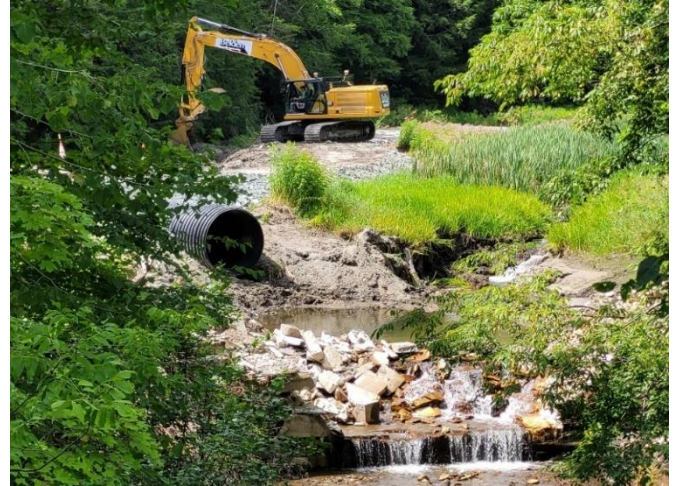
Breached face of the Pelletier Dam and impoundment (August, 2022)
