## PROJECT BRIEF : Evaluating the Effects of Rain Gardens in a Vermont Community

St. Albans, Vermont

January 2014

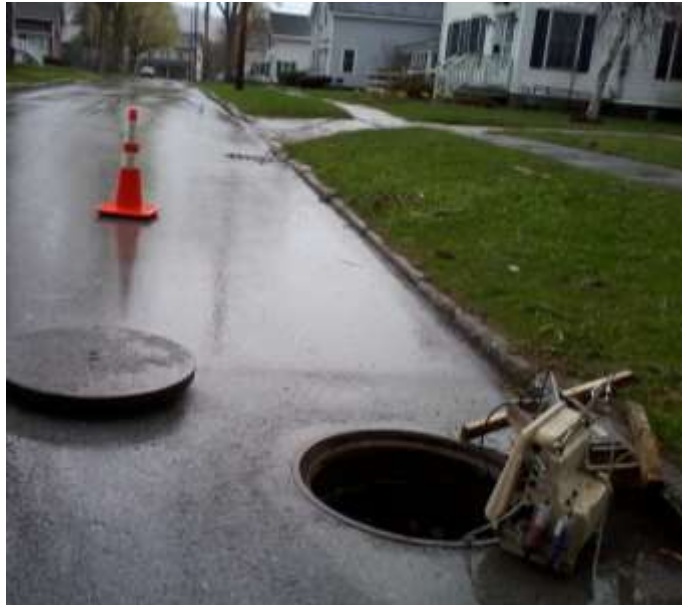
*Manhole on Rugg Street in which flow monitoring equipment was deployed, St. Albans, VT.*

Stone's work involved developing a monitoring plan and procedures; specifying, installing, and maintaining monitoring equipment; and analyzing flow and water quality data. In 2010 and 2011, continuous flow monitoring was performed within stormwater manholes on Rugg and Ferris Streets. An electronic tipping bucket rain gauge was used to measure rainfall. Flows in the Ferris Street and Rugg Street storm sewers were monitored for a sufficient number of events to establish a characteristic, statistical relationship between their hydrologic responses.
