Deer Brook Gully Restoration, Georgia, Vermont

DEER BROOK is an 8.4 square mile watershed located in Georgia and Fairfax that flows south to Arrowhead Mountain Lake, part of the Lamoille River, drains to Lake Champlain. The brook is classified as sediment impaired from its confluence with Arrowhead Mountain Lake to 2.5 miles upstream. The construction of I-89 and related U.S. Route 7 improvements in the 1970s and the subsequent addition of homes and businesses near the intersection with Route 104A have contributed to a substantial increase in stormwater runoff discharging to the head of the Deer Brook Gully. These stormwater flows and deteriorating culverts along Route 7 and 104A in Georgia have caused the gully to erode and deposit sediment into Deer Brook. The problem was first documented by Erosion Prevention and Sediment Control (EPSC) and Stone in a 2007 report for the Northwest Regional Planning Commission (NRPC). Stone further evaluated the site and provided conceptual solutions to reduce flows to the Deer Brook Gully as part of a 2013 stormwater master planning project for the Friends of Northern Lake Champlain (FNLC) in Georgia, Vermont.

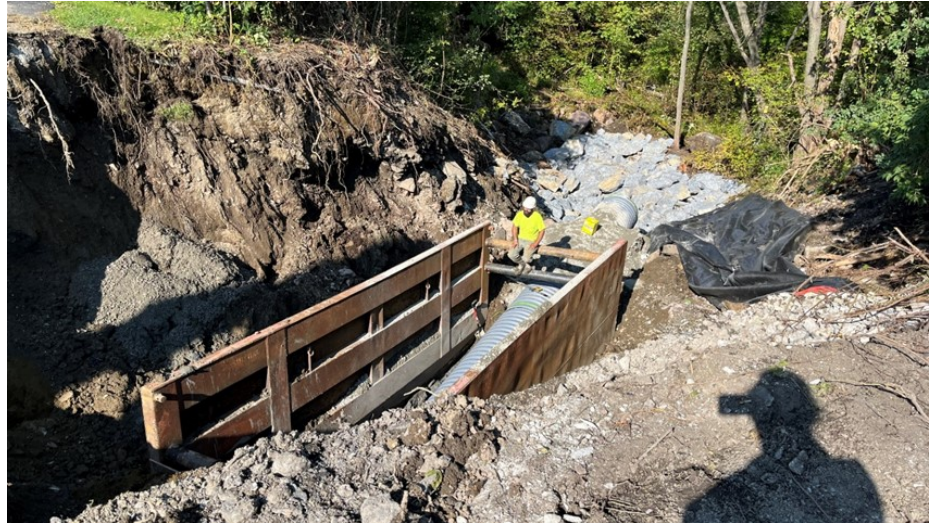
Installation of the new outfall and energy dissipating stone step pools on September 14, 2022.

The portion of the project that constructed in 2022 included gully and bank stabilization and installation of the upsized outfall, deep manhole, and one deep sump catch basin and all associated piping. It is the hope of all interested parties that the remainder of the large-scale project can be constructed in future phases.

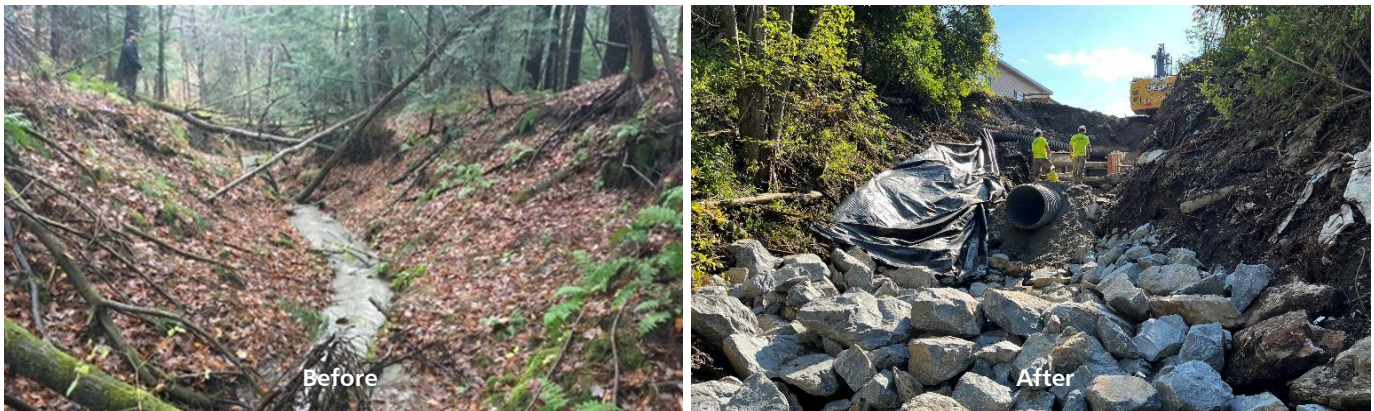
Left: Existing condition in the lower reach of Deer Brook gully, seen in November 2017. Gray-colored water in the channel is due to fine sediment transport during a moderate rain event. Right: Construction of new outfall and energy dissipating stone step pools in September, 2022
