## Fisherville Mill – A Case Study – Cost Effective Remediation Through Collaboration

Ollila, Paul; Soukup, Jim; Nowack, Bette; Bernat, Eugene; Brammer, Dean; Hultstrom, Eric; and Tsang, Janis (2008) "Fisherville Mill – A Case Study – Cost Effective Remediation Through Collaboration," *Proceedings of the Annual International Conference on Soils, Sediments, Water and Energy*: Vol. 13, Article 10.

### FISHERVILLE MILL - A CASE STUDY- COST EFFECTIVE REMEDIATION THROUGH COLLABORATION

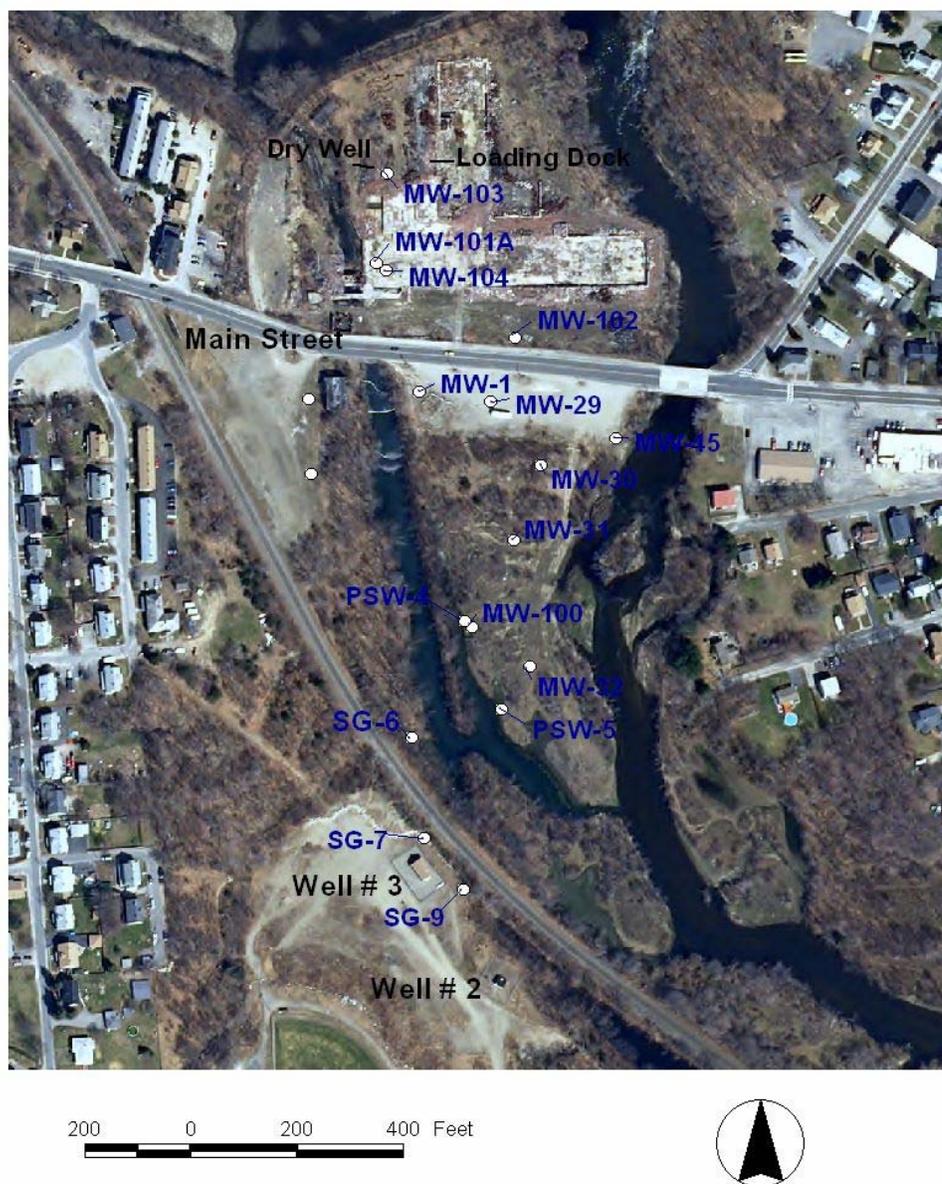
Figure 2. Orthophoto showing the former mill, the peninsula and monitoring well locations.

Central Massachusetts Economic Development Authority (CMEDA). Main Street (Route 122A) divides the site into two roughly equal areas (Figure 2). The mill occupied the area north of Main Street. The area south of Main Street (the “peninsula”) is undeveloped and is bounded by the Blackstone River on the east and the Blackstone Canal on the west and south.

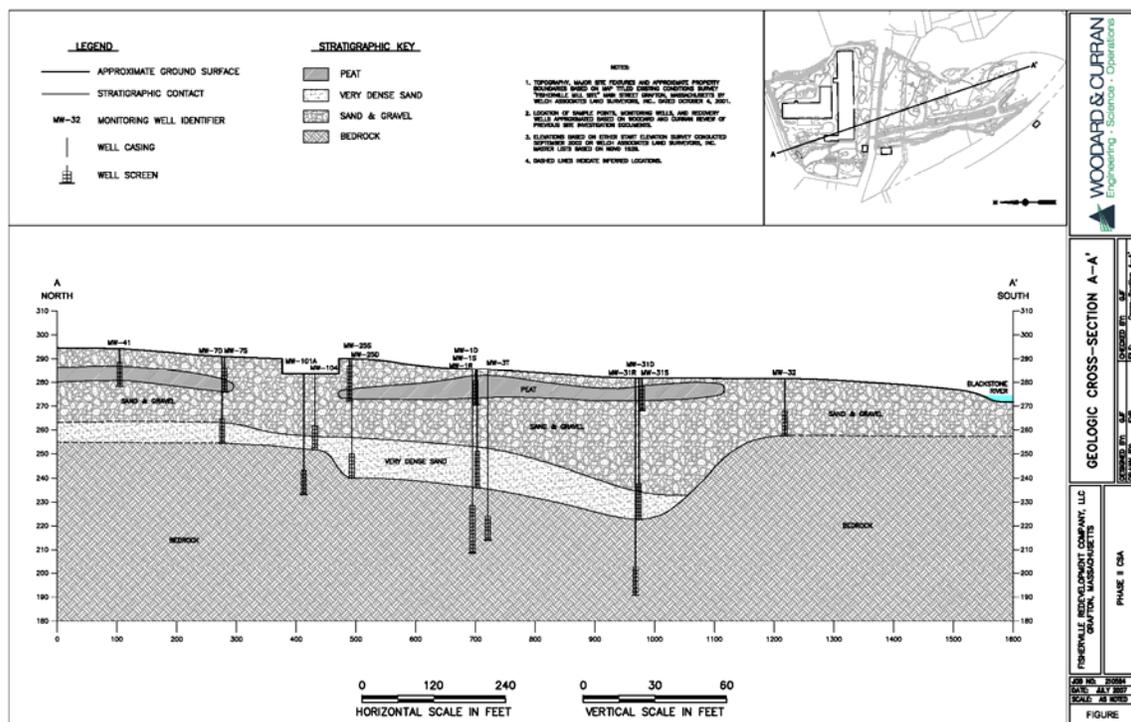
Figure 3. Geologic cross section from Fisherville Pond to the southern end of the peninsula.

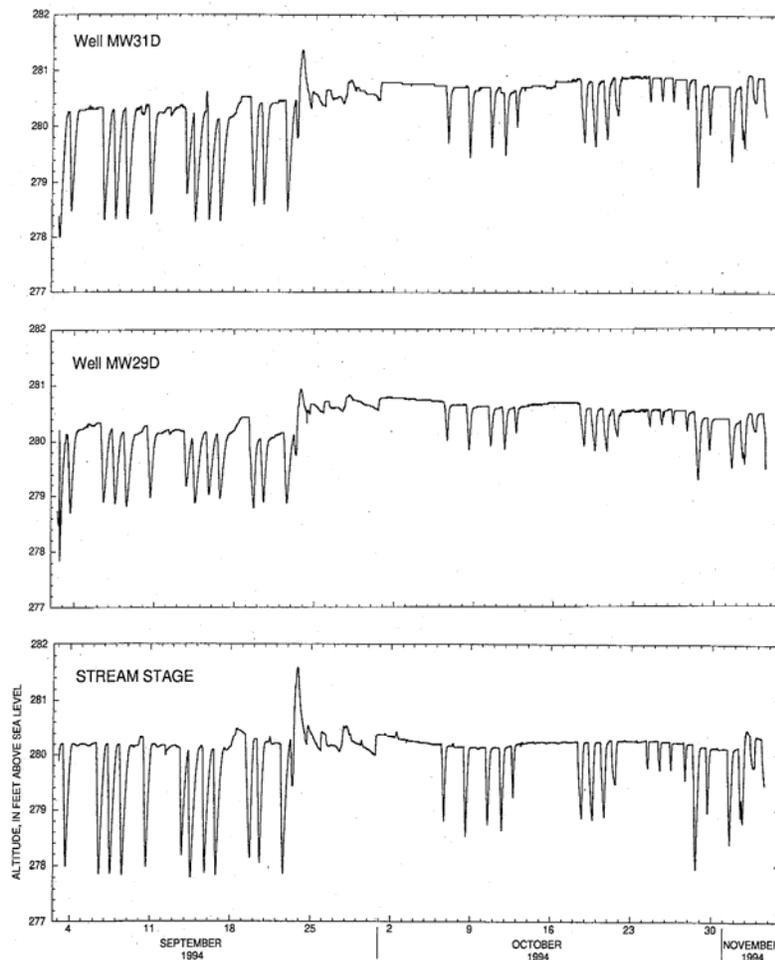
Figure 4. Groundwater and surface water elevations measured in 1994 by the USGS (Desimone and Barlow, 1995).

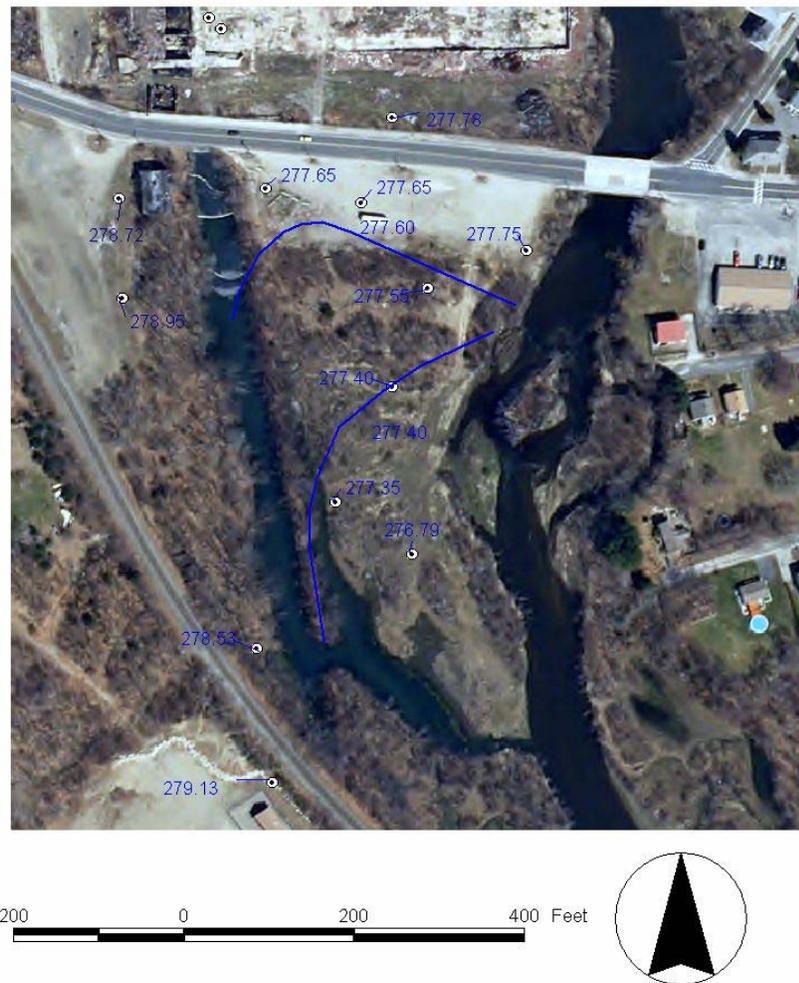
Figure 5 is a potentiometric contour map based on July 2001 gauging data for deep overburden monitoring wells. On July 16, 2001, deep groundwater was flowing under the canal towards the Blackstone River. Based on gauging data from monitoring wells near the canal, and piezometers and surface water gauges installed in the canal, shallow to intermediate depth groundwater was discharging to the canal. This is not the case during dry parts of the year when Well #3 is in use.

Figure 5. Potentiometric contours (277.6 and 277.4 feet) based on water elevations measured in deep overburden monitoring wells on July 16, 2001.

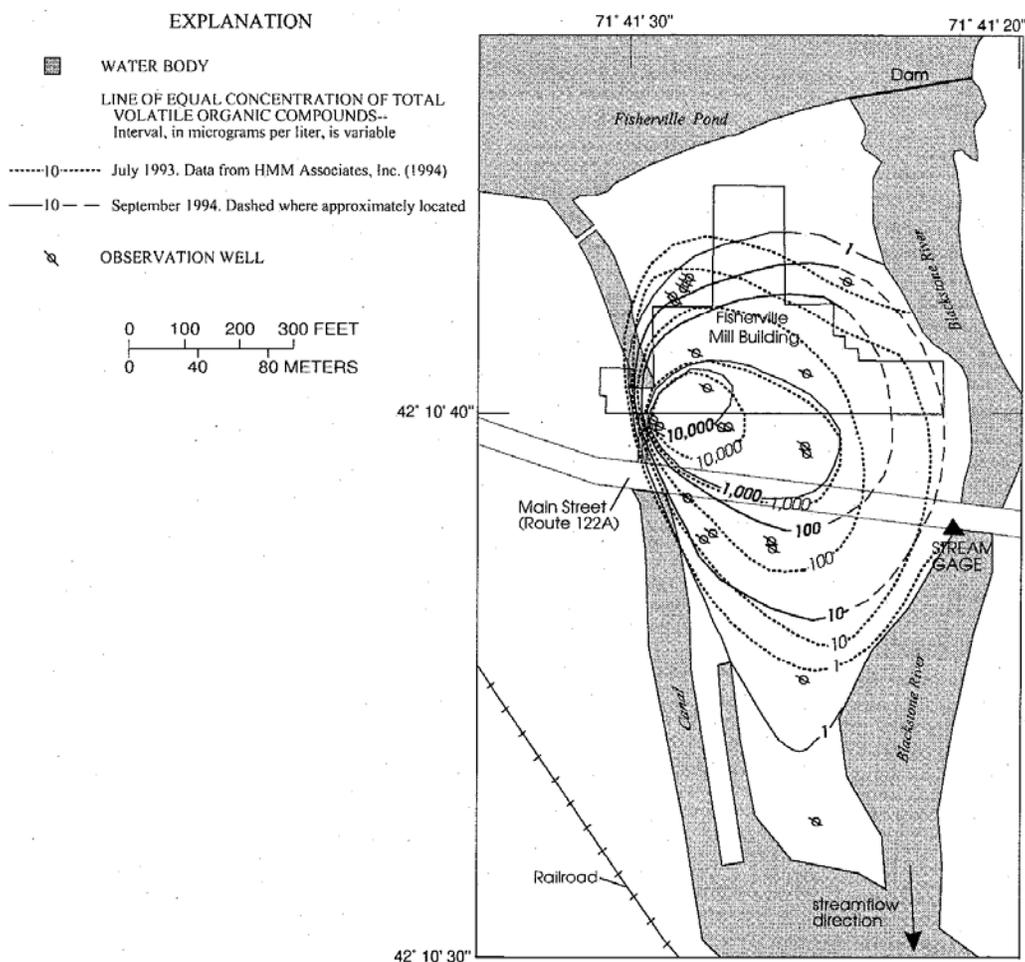
Figure 6. Total VOCs (ug/l) measured in groundwater samples collected in July 1993 (HMM, 1994) and in September 1994 (Desimone and Barlow, 1995).

Probably the best indicator of the change of hydrologic conditions between 1994 and 2000 is the change in contaminant distribution patterns. Figure 6 shows total VOC concentrations in 1993 and 1994. VOCs were either not detected or at very low concentrations in wells located on the southern part of the peninsula. Figure 7 shows the changes in TCE concentrations in selected peninsula monitoring wells after the fire. TCE is the principal VOC in all the selected wells. After the fire, TCE concentrations first increased in MW-1D followed by MW-31R, MW-1R, MW-31D, MW-31S, and MW-32D. In the fall of 2000, VOC concentrations in peninsula monitoring wells were higher and VOC contamination extended further south than in 1993 and 1994.

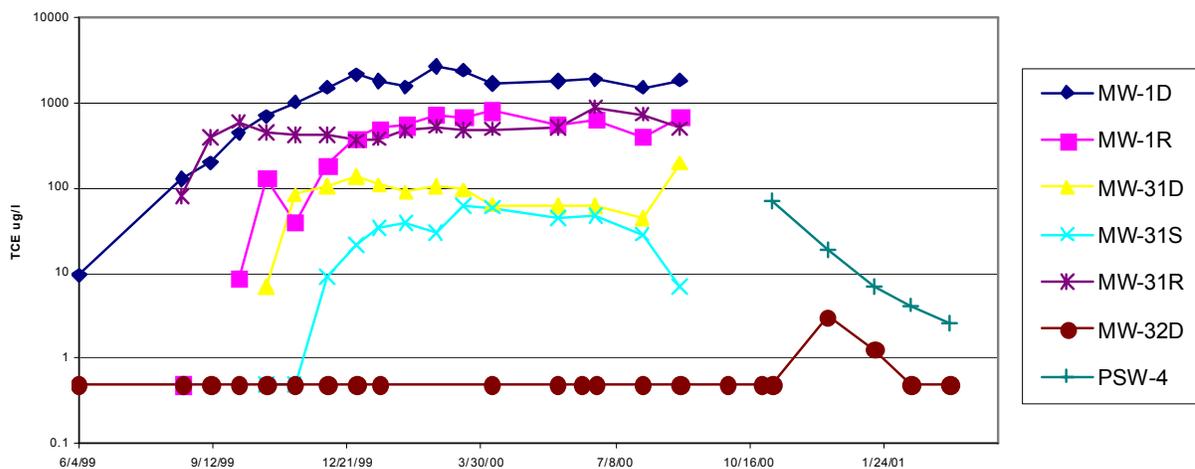
Figure 7. VOC concentrations measured in groundwater samples after the August 1999 fire.

SGWD Well #3 is screened at the base of the sand and gravel aquifer from 37 to 43 feet below grade and has a maximum permitted yield of 450 gallons per minute. In January 2001, the SGWD reported that 0.7 ug/l of TCE had been detected in a sample collected from Well #3 in November 2000. The SGWD stopped using Well #3 shortly after the November sample was collected because water levels had recovered at a well (Well #1) located in another part of the town. Interpretation of the November sampling results for Well #3 was difficult because TCE was not detected in a sample collected from monitoring well SG-7 that is located between Well #3 and the Fisherville Mill Site. After the SGWD stopped using Well #3 and after water levels increased, TCE concentrations in PSW-4 decreased compared to concentrations measured in November 2000 (Figure 7).

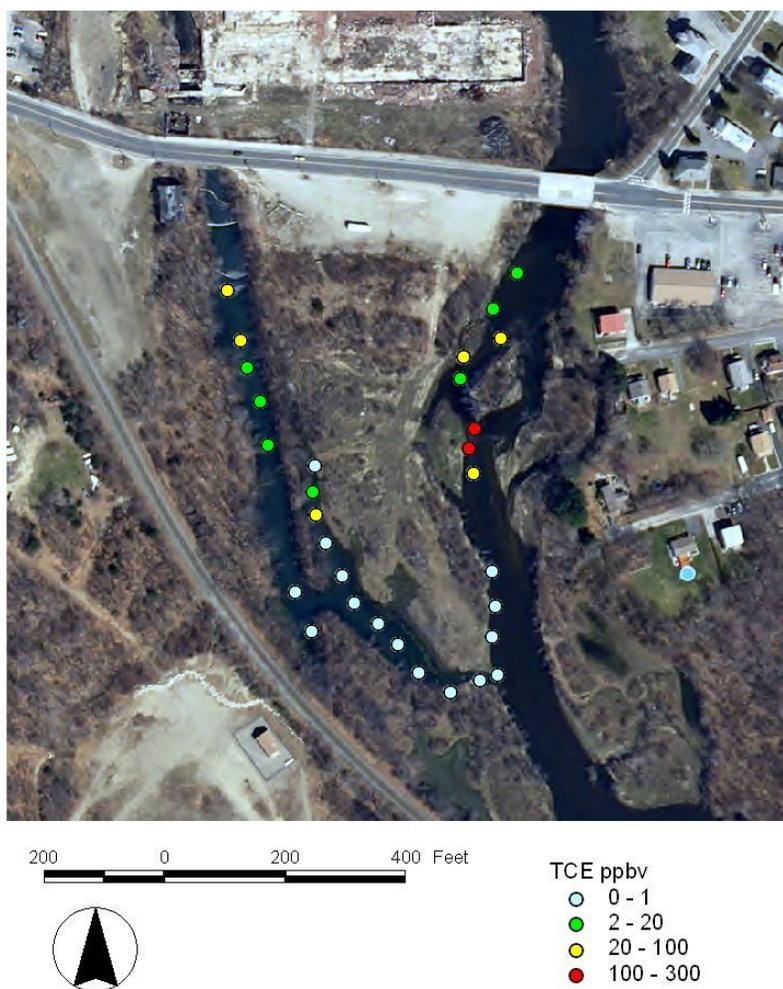
*Figure 8.* TCE concentrations measured in passive vapor diffusion samplers (ppbv) in June 2000.

MassDEP conducted a passive vapor diffusion sampler (PVDS) study in June 2000 in order to provide more information about the fate of the VOC plume on the peninsula (Figure 8). TCE contaminated water was discharging to the Blackstone River and Canal but VOCs were not detected in samplers located near the southern end of the peninsula. CVOC concentrations in surface water samples collected from the canal near the former mill have been as high as 574 ug/l. CVOCs have not been detected in surface water samples collected from the Blackstone River.

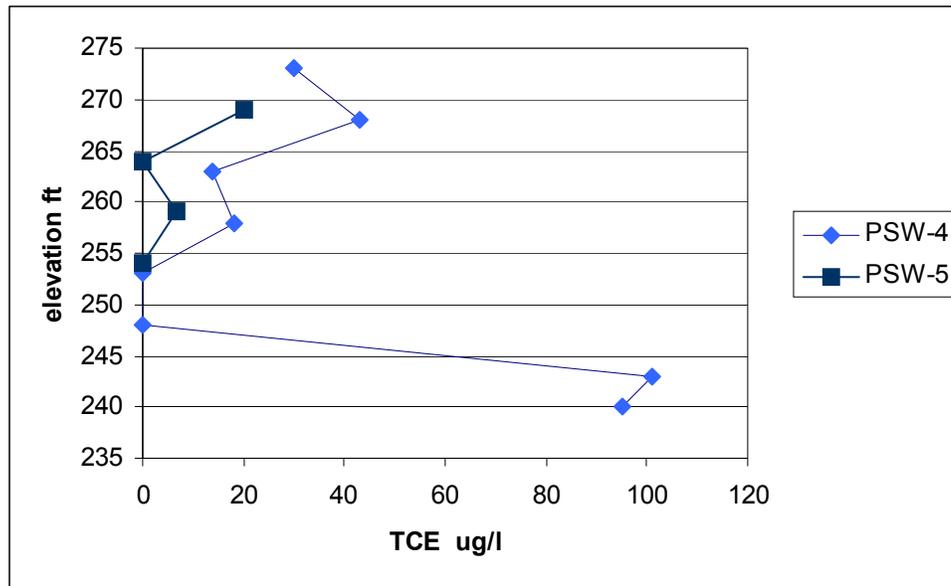
Figure 9 shows TCE concentrations measured in groundwater samples collected at five-foot vertical increments on the western side of the peninsula near (PSW-4) and south (PSW-5) of the MW-100 location. CVOCs were present in the upper part of the aquifer, CVOCs were not present at intermediate depths, and concentrations were highest near the bottom of the overburden aquifer.

Figure 9. TCE measured in groundwater samples collected at five-foot intervals on the western side of the peninsula at locations PSW-4 (near MW-100) and PSW-5.

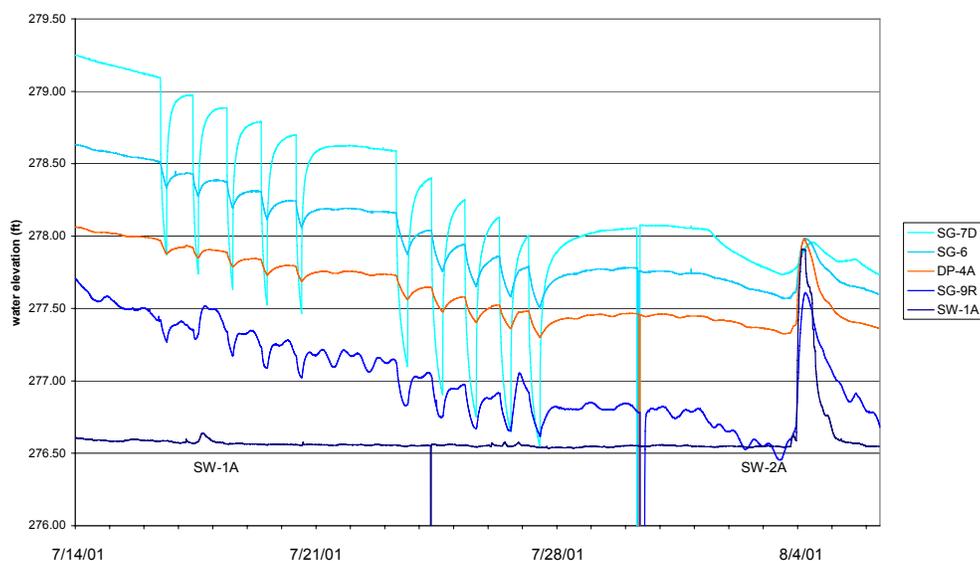
Figure 10. Water elevations measured in monitoring wells located on the western side of the canal.

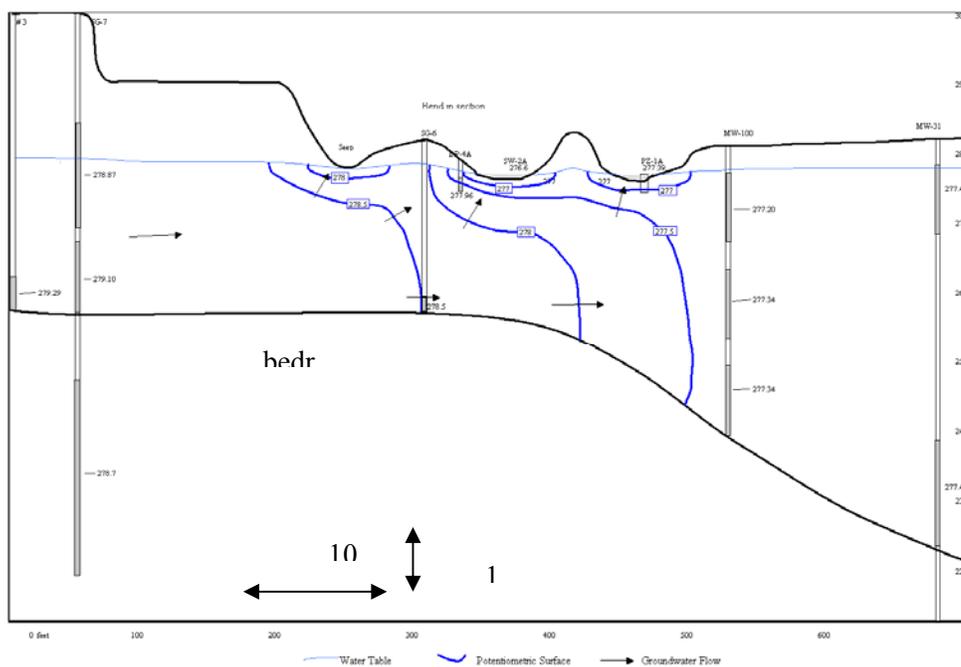
Figure 13. Potentiometric contours between SGWD Well #3 and MW-100S, M and D based on water elevations measured on October 25, 2001.

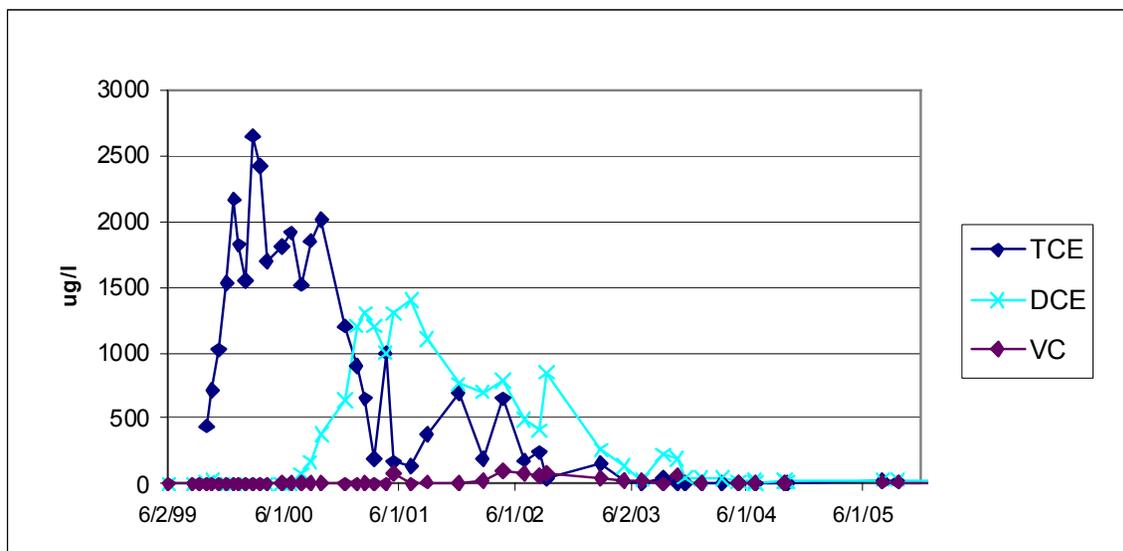
Figure 14. Trichloroethene (TCE), cis-1,2-dichloroethene (DCE) and vinyl chloride (VC) concentrations measured in groundwater samples from monitoring well MW-1D.

In the month following installation of the dam, TCE concentrations decreased in MW-1D, 31D and 100D. Concentration changes shown in Figures 14 and 19 are similar in all three wells. However, during the late summer of 2002 when water levels dropped below the crest of the dam and the SGWD started using Well #3, TCE concentrations increased in all three monitoring wells. After water levels rose in the winter and spring of 2003, TCE concentrations decreased in the three wells and remained low until the fall of 2003. The increases in concentrations during the fall of 2003 were less than in 2002. This was the case even though the SGWD pumped

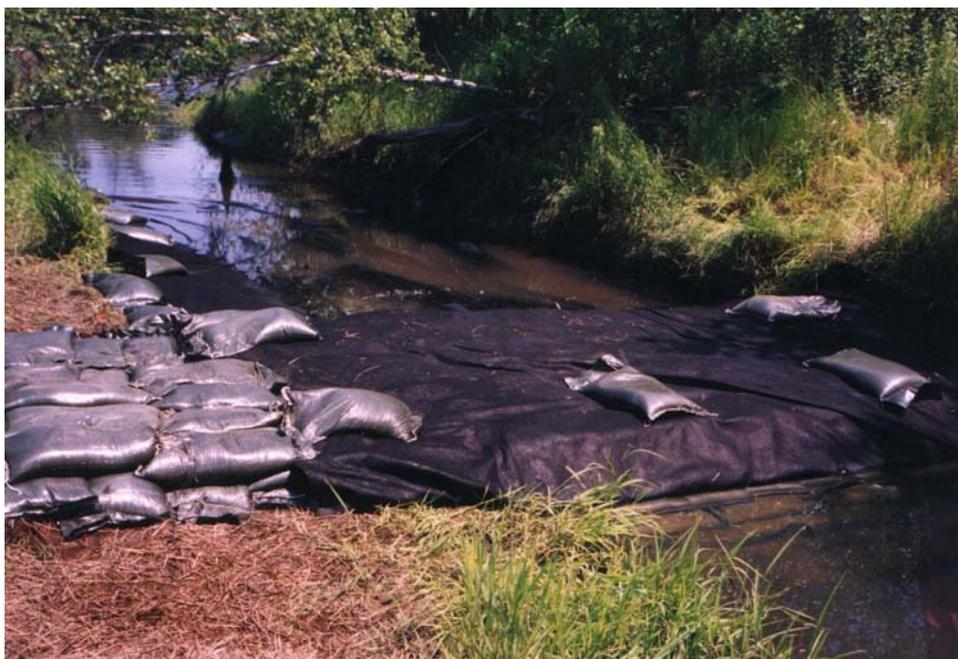
The EPA completed installation of a temporary sand bag dam (Figure 15) near the confluence of the Blackstone River and Canal south of the former Fisherville Mill (Figure 2) on June 28, 2002 and replaced the sand bag dam with a sheet-piling dam (Figure 16) during December 2003. The dam was installed to deflect the CVOC plume away from Well #3. Figure 17 shows potentiometric contours after the dam was installed. Average groundwater elevations, except for the area influenced by the dam, were similar on July 16, 2001 (Figure 5) and July 12, 2002 and comparison of Figures 5 and 17 illustrates the dam's effect on potentiometric gradients in the deep overburden aquifer. After installation of the dam, water elevations in monitoring wells near the canal (MW-1D, MW-100D) increased relative to monitoring wells located in the center of the peninsula (MW-29D, MW-31D, MW-32D). Installation of the dam enhanced flow to the east towards the Blackstone River. During the late summer of 2002, when water elevations in the canal dropped below the crest of the dam, potentiometric gradients were similar to pre-dam conditions. This pattern persisted until water levels increased during late October 2002.

*Figure 15.* Sand bag dam installed in June 2002.

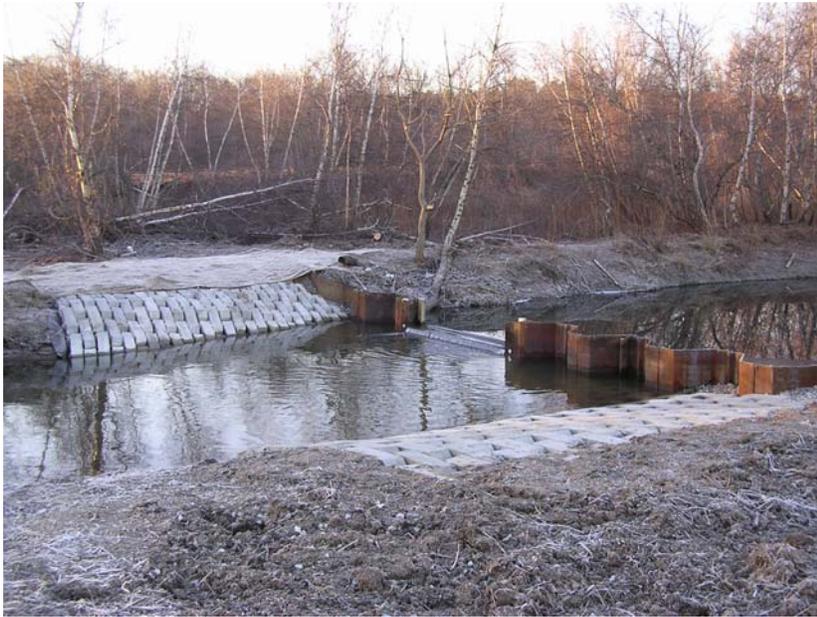
Figure 16. Sheet-piling dam installed in December 2003.

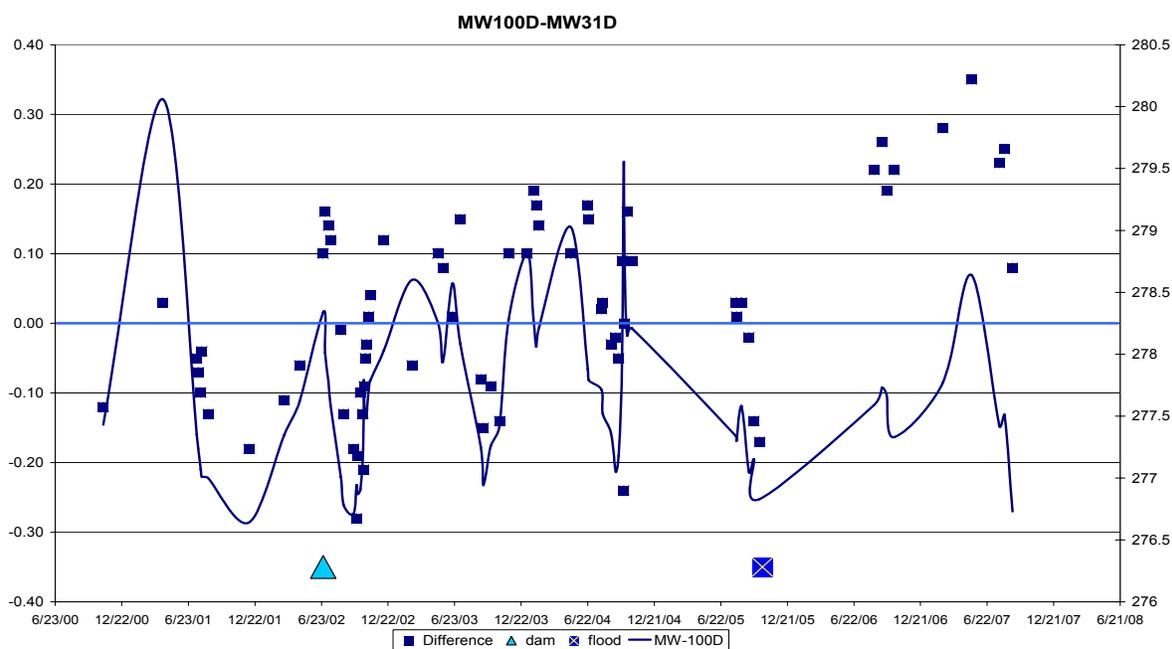
Gauging data for MW-31D and 100D are summarized in Figure 18. Gauging data for MW-1D and 29D exhibited a similar pattern. After the dam was installed in late June 2002, gradients between MW-31D and 100D, and MW-1D and 29D reversed. Gradients reversed again in mid-August 2002 as water levels in the canal dropped and have reversed numerous times during the five years since the dam was installed. Water elevations in MW-100D and MW-1D were greater than elevations in MW-31D and MW-29D respectively during most of the winters, springs and early summers of 2003, 2004 and 2005, and this pattern has been more persistent since a flood in October 2005 deposited up to two feet of sediment on the peninsula and deepened the Blackstone River channel. When the water elevation in MW-100D is higher than the elevation in MW-31D and the elevation in MW-1D is higher than in MW-29D (i.e. the difference is  $> 0$  in Figure 18), the VOC plume migrates to the southeast away from South Grafton Water District (SGWD) Well #3.

*Figure 18.* The difference in groundwater elevations between MW-100D and MW-31D and the groundwater elevation measured in MW-100D. The dam was installed on June 28, 2002 (blue triangle) and a major flood occurred on October 14, 2005 (dark blue square).

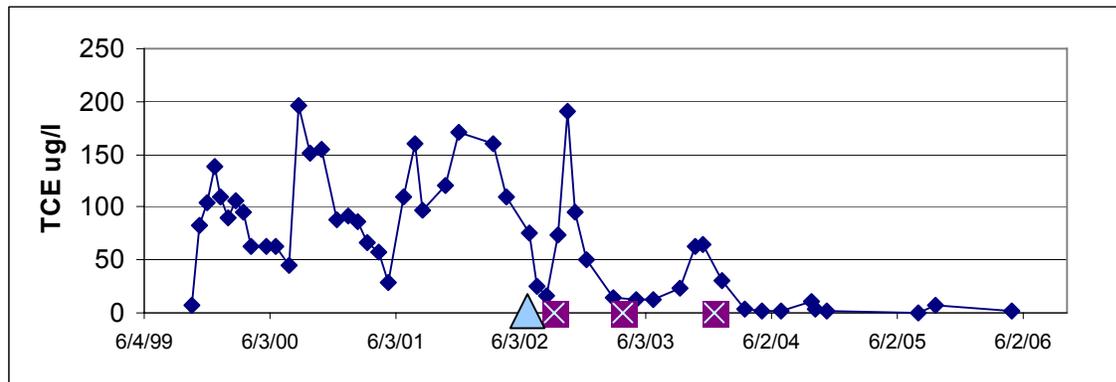
Figure 19. TCE concentrations measured in groundwater samples collected from MW-31D.

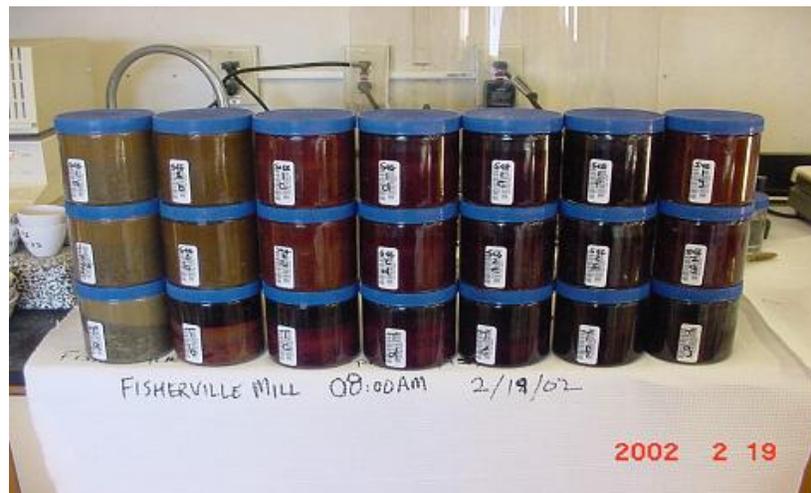
*Figure 21. Sodium Permanganate Bench-Scale Treatability Testing*

Based on the bench scale treatability test results, the recommended dosage rate was 4 g of sodium permanganate for every kg of soil. For purposes of full-scale implementation of ISCO at the site, this equated to injection of 1,244-pounds of  $\text{NaMnO}_4$  per injection point. Permanganate dosage rates for ISCO are highly dependent on the amount of naturally occurring organic matter present in the site soils. During the treatability testing, soil samples were collected and analyzed for TOC. TOC concentrations in the untreated soil samples varied from 1,541-milligram/kilogram (mg/kg) in the till sample to 3,283-mg/kg and 4,483-mg/kg in the outwash samples. More than 50% of the TOC remained in the samples after treatment with permanganate. The relationship between soil TOC concentrations and permanganate demand was evaluated by Siegrist, et al. In the studies reviewed, the ratio of permanganate to TOC varied from 2-mg to over 100-mg of permanganate per milligram of TOC. Dosages of 2-mg to 10-mg permanganate per milligram TOC were most common. Increases in oxidant consumption were observed with increases in the oxidant dose concentration. Based on a minimum theoretical dosage of 2 mg permanganate per mg of TOC, and an average TOC concentration of 3,000 mg/kg, a theoretical dosage of 7.2 g  $\text{NaMnO}_4$  per kg of soil, or 2,240-pounds of  $\text{NaMnO}_4$  per injection point, was calculated. This is approximately 1.8 times the dosage estimated above, which is based on the VOC destruction observed during the treatability testing.

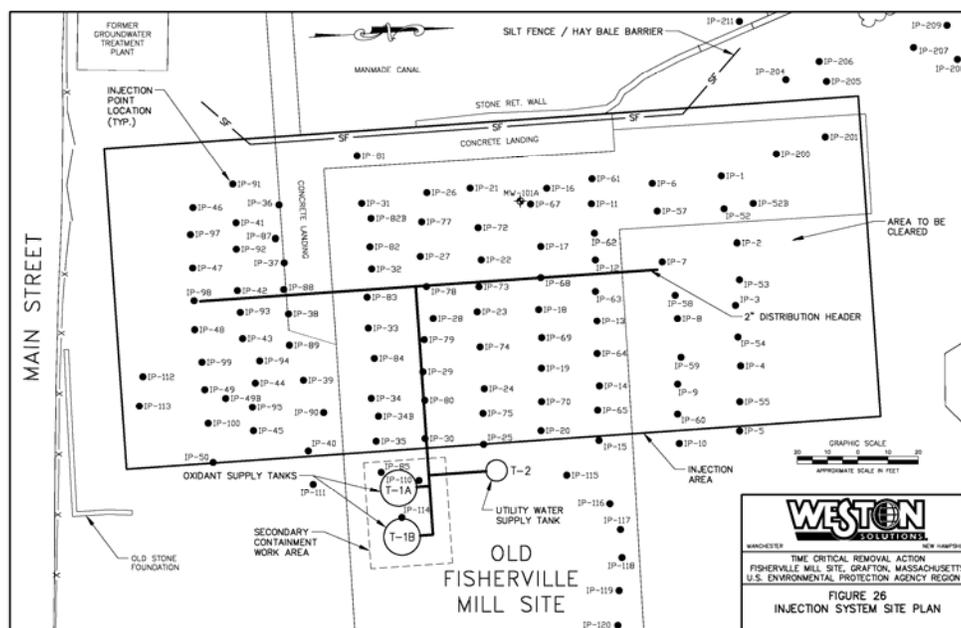
The area targeted for application of the oxidant is shown on Figure 22 and was chosen based on soil and groundwater quality data collected during historical site characterization work. The treatment area was approximately 100-ft by 200-ft, with the long axis parallel and abutting the Blackstone Canal, and a southern terminus at Main Street. This area was considered a conservative estimate of all areas with groundwater and/or soil with concentrations greater than 1 mg/L total volatile organic compound (VOCs). A total of 100 injection points are included within the treatment area. The injection point grid consisted of 10 rows spaced 20-ft apart in the direction parallel to groundwater flow (roughly north to south). Each row consisted of 10 injection points spaced 10-ft apart in the direction perpendicular to groundwater flow (roughly east-west). The spacing of the injection points was greater in the direction parallel to groundwater flow because of the convective transport that will occur in that direction. Each row was offset from the previous row by 5-ft so that the rows did not line up in the downgradient direction. This was done to prevent untreated zones from developing between the injection points.

Figure 22. Injection System Layout

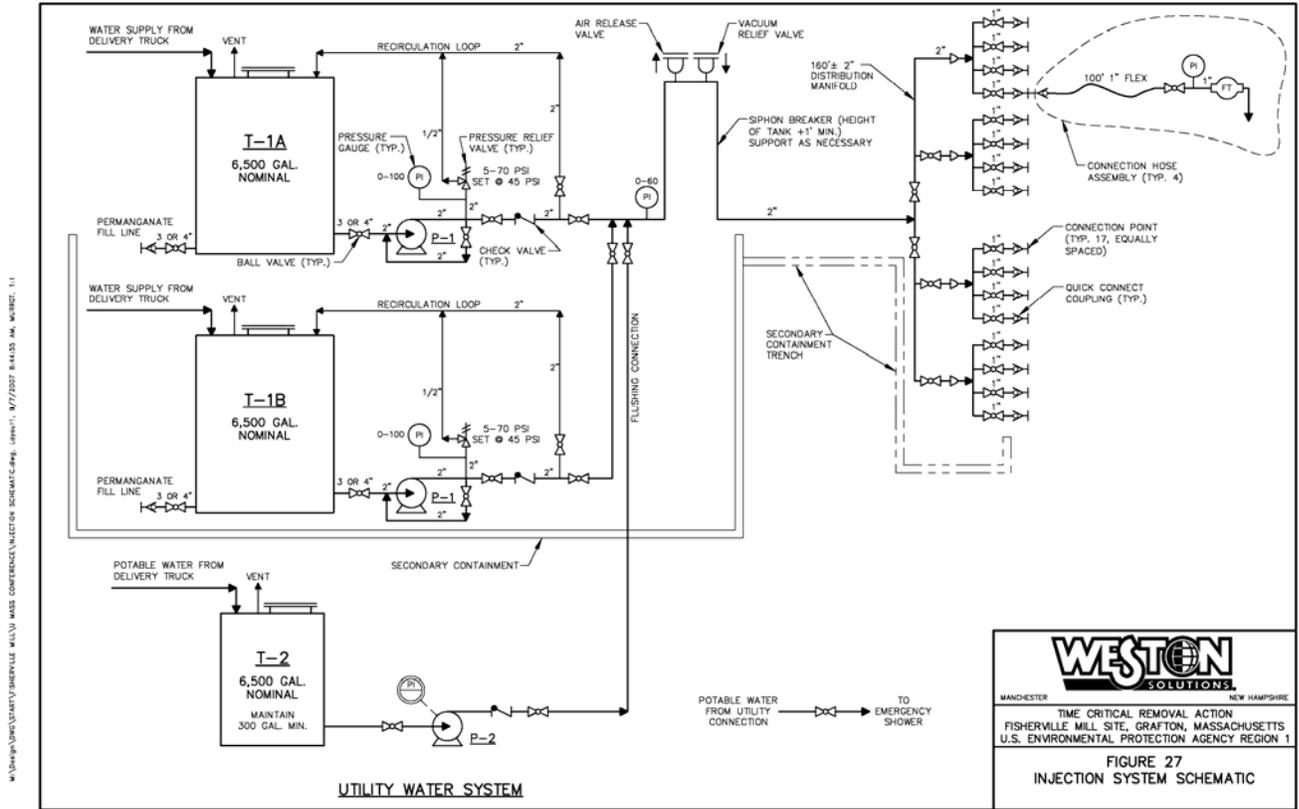
In August 2002 permanganate injections were initiated at the site with placement of the injection storage and pumping equipment including: three 6,500 gallon polyethylene storage tanks, three 250-gallon stainless steel tanks, two temporary containment structures, and two 3.5-horsepower centrifugal pumps. Two of the 6,500-gallon tanks used for the sodium permanganate solution storage were placed within containment structures. The third 6,500-gallon tank and the three 250-gallon tanks were utilized for clean water storage. Figure 23 is a schematic diagram of the injection system and Figure 24 is a photograph of the system as constructed.

Figure 23. Injection System Schematic

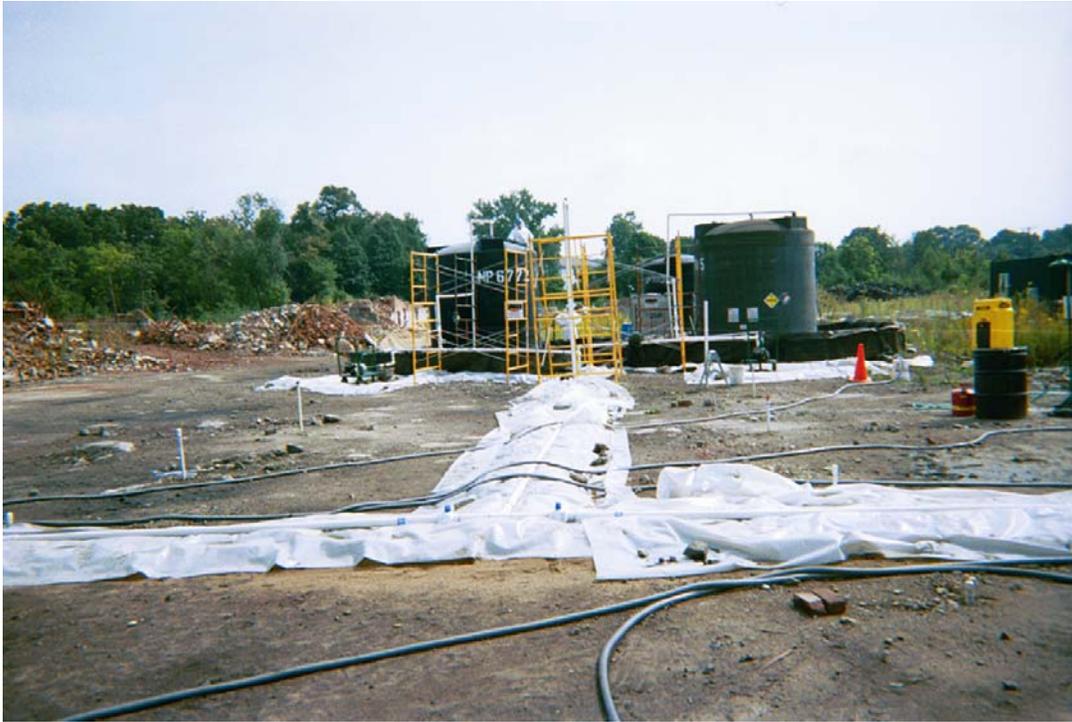
*Figure 24. Permanganate Mixing Tanks and Distribution Manifold.*

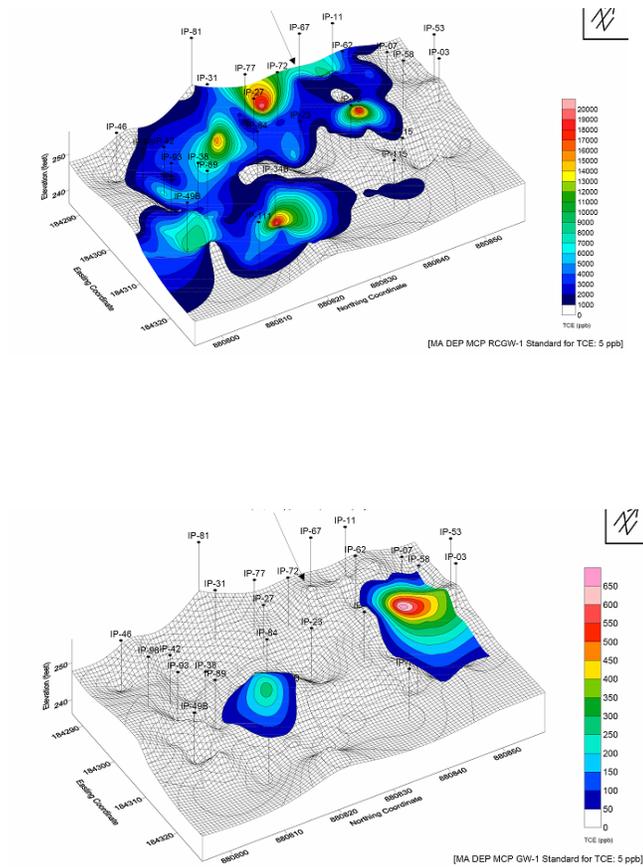
Figure 25. Distribution of TCE in Treatment Grid before and after ISCO (note change in concentration scale between figures).

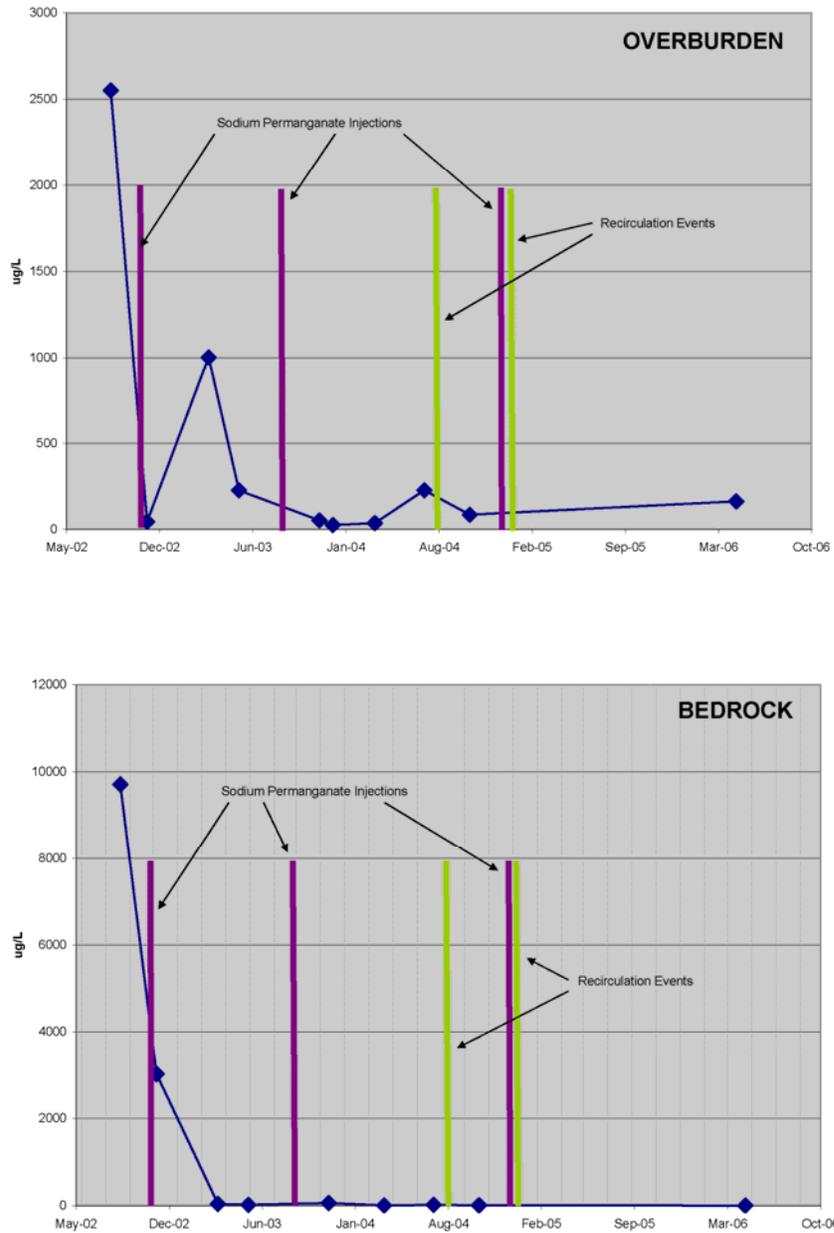
Figure 26. Average Total VOC concentration in source area in overburden and bedrock.

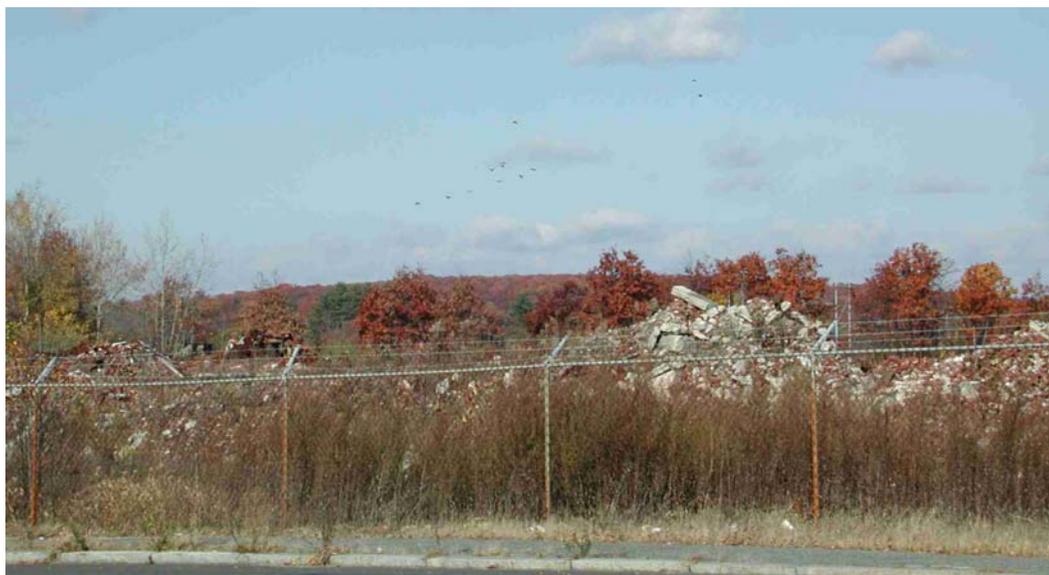
*Figure 28.* Fisherville Mill Site before encapsulation with flowable fill.

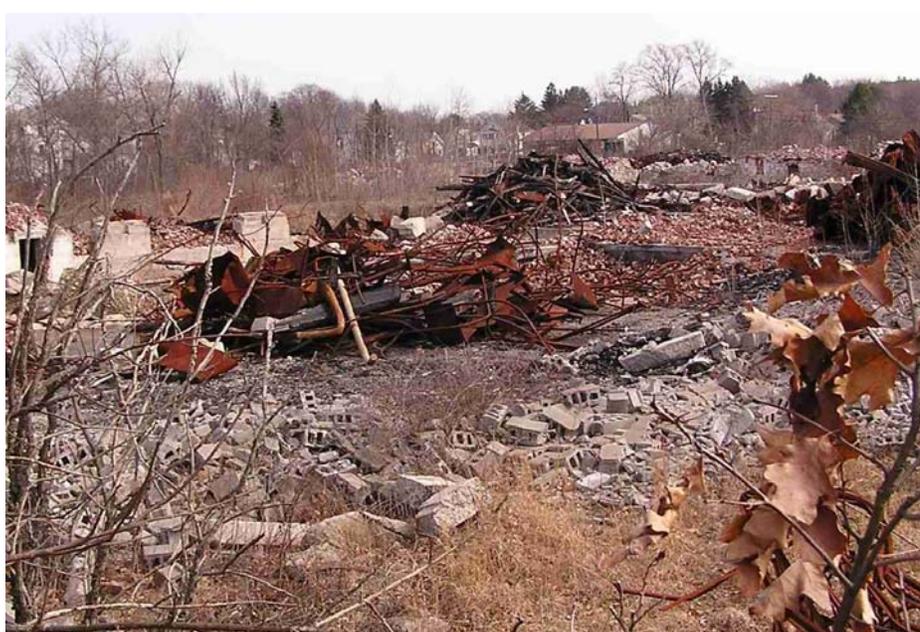
*Figure 29.* Debris piles at Fisherville Mill before remediation

Though significant money had been spent by the EPA and MassDEP, CMEDA and others to stabilize the site and remove grossly contaminated waste immediately following the 1999 fire; enormous piles of asbestos containing materials containing, ash, contaminated soil, wood, steel, brick, concrete debris as well as remnant piping, machinery, and foundations virtually covered

the entire site. As the cleanup of this visual and environmental blight was the highest priority of the community expressed during the consensus building process, the company determined that addressing this problem should form the foundation of the remedial approach at the site. Immediately addressing this high visibility issue at the outset of the remediation process reinforced and validated the company's core remedial concept of rapidly implemented improvement in site environmental conditions from both a public and regulatory perspective.

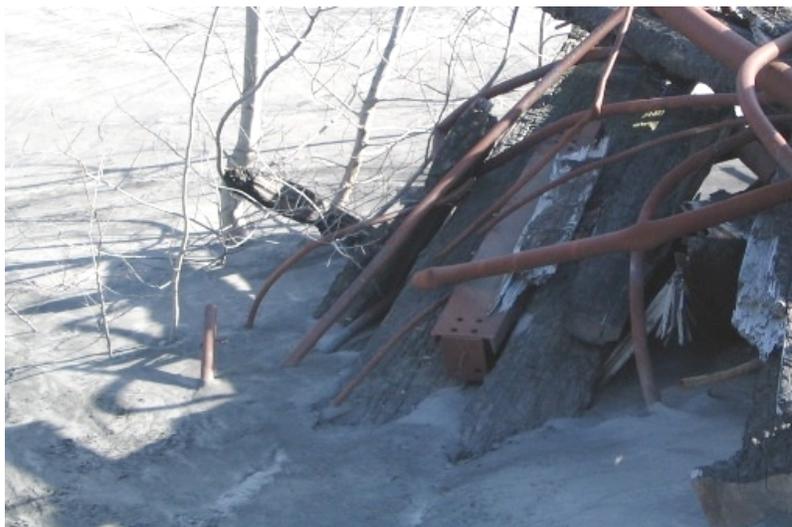
*Figure 30.* Encapsulation of debris with flowable fill.

In the first twelve months of the remediation project the former foundation holes of the mill buildings and the associated debris were encapsulated with a commercially available flowable fill product. A few discrete areas of debris piles with heights that exceeded the depth of flowable fill were relocated under a MassDEP approved asbestos work plan that included the use of wetting techniques and perimeter monitoring for asbestos fibers.

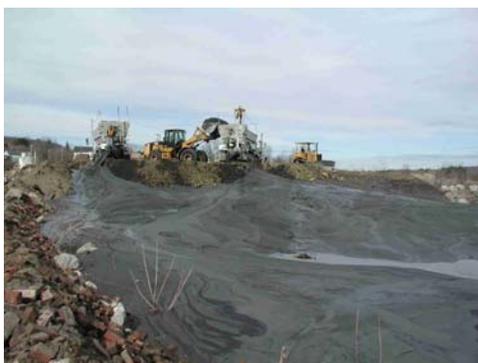
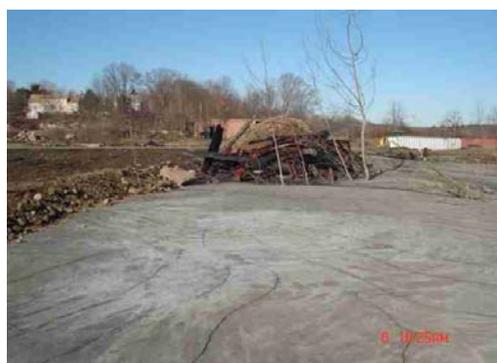
The flowable fill was prepared on-site using a portable batching systems in general accordance with the Massachusetts Highway Department (MHD) specifications for Type 1E (very flowable and excavatable) Controlled Density Fill as described in the December 11, 2002 “MHD Supplemental Specifications for Highways and Bridges” in subsection M4.08.0. The materials for flowable fill were processed in a mobile batching plant in an elevated location immediately adjacent to the application area. The flowable fill pours directly down the chutes from the portable batching system. The flowable fill is self-leveling and generally does not require any grading or reshaping to fill each application area.

*Figure 31 (left).* Application of flowable fill to encapsulate debris. *Figure 32 (right).* Flowable fill after setting and curing.

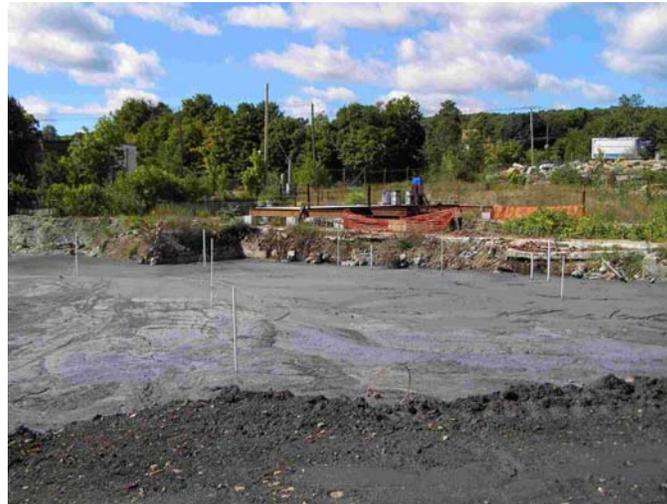
Infrastructure for a soil vapor extraction (SVE) system was installed in the shallow overburden soil in the front foundation area to allow for the potential future treatment of this area by SVE, as necessary. Due to the presence of shallow groundwater in this area, SVE wells were installed in a horizontal configuration. Vertical risers were run to the top of the foundation wall and capped. Existing monitoring and injection wells were extended above the final grade of the flowable fill to allow access for future monitoring and remedial actions.

*Figure 33.* Application of flowable fill in front foundation area in conjunction with SVE piping, monitoring wells and injection points.

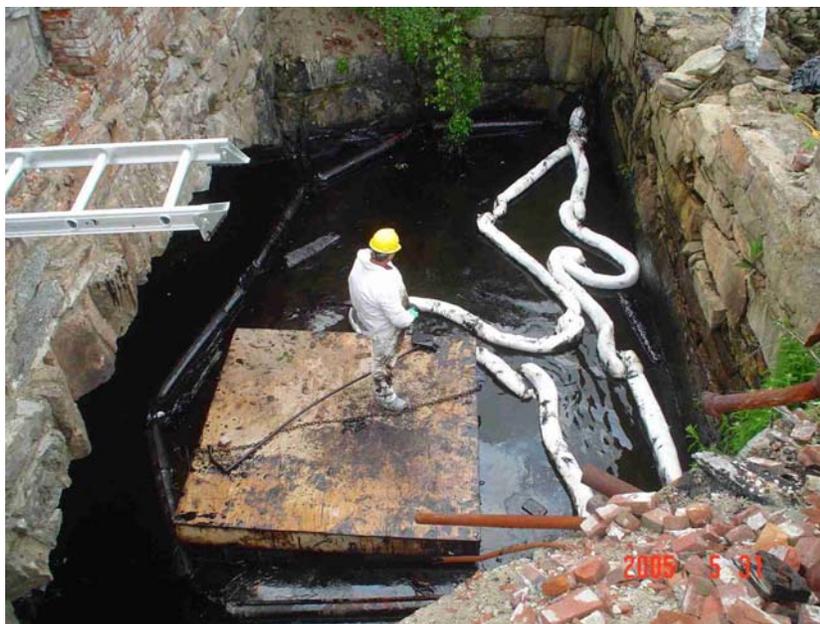
In 2004, the primary oil recovery technique was the containment of oil in the canal downstream of the tailraces, with absorbent booms and the periodic skimming of accumulated oil with a vacuum truck. This technique was expensive, labor intensive, and prone to occasional failure if there were large volumes of water flowing through the canal.

*Figure 34.* Oil absorbent boom change out in canal near tailraces

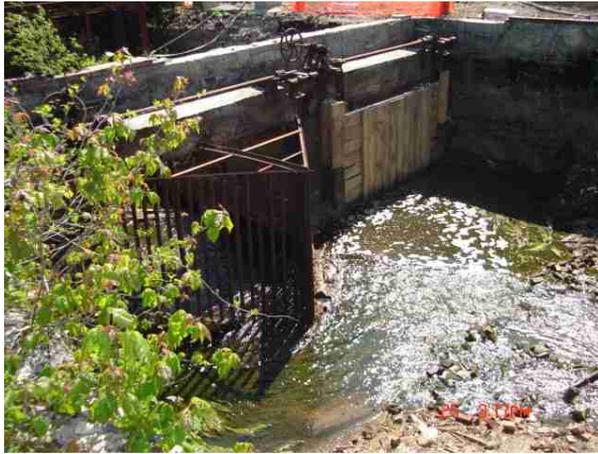
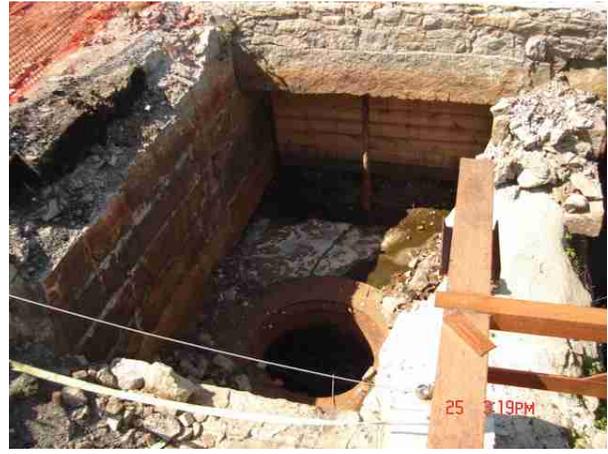
*Figures 35 and 36.* Channel diversion wall installed in 2005 to direct canal water away from the oil-impacted western tailrace.
