## Fisherville Mill – A Case Study – Cost Effective Remediation Through Collaboration

Ollila, Paul; Soukup, Jim; Nowack, Bette; Bernat, Eugene; Brammer, Dean; Hultstrom, Eric; and Tsang, Janis (2008) "Fisherville Mill – A Case Study – Cost Effective Remediation Through Collaboration," *Proceedings of the Annual International Conference on Soils, Sediments, Water and Energy*: Vol. 13, Article 10.

### FISHERVILLE MILL - A CASE STUDY- COST EFFECTIVE REMEDIATION THROUGH COLLABORATION

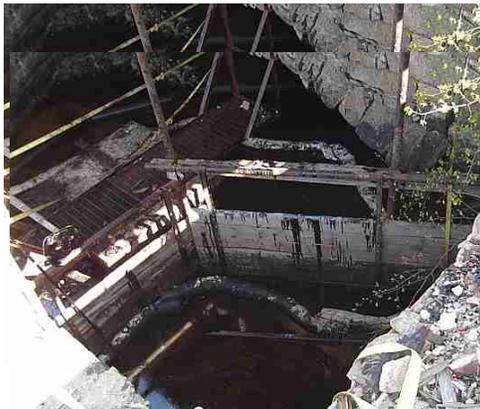
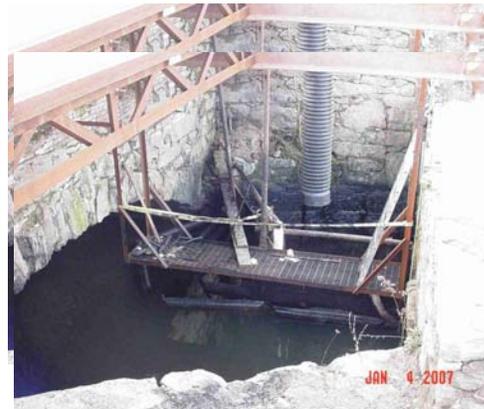
*Figures 37 and 38.* A containment wall was installed at the western tailrace to corral the oil and allow for collection with a belt skimmer.

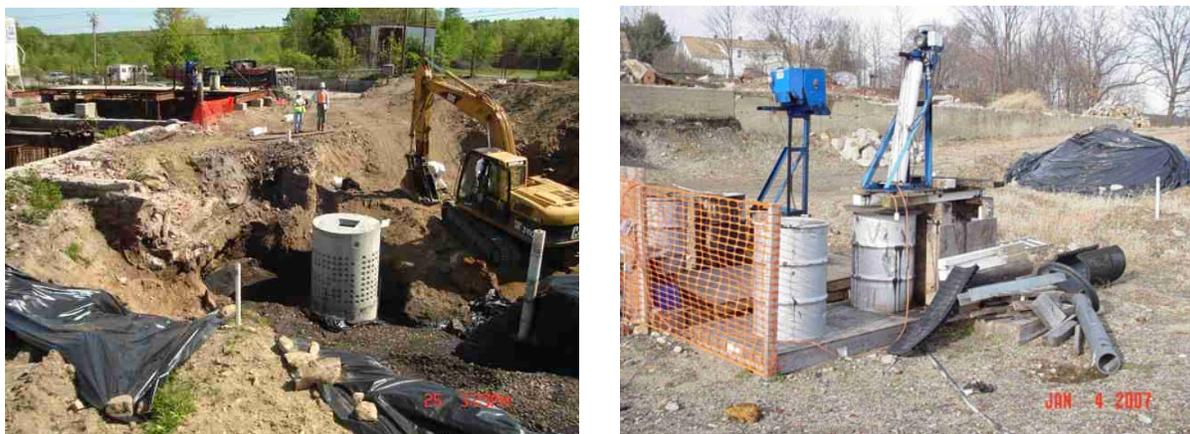
Two recovery wells were installed using sections of perforated concrete leaching basins in an area adjacent to the location of the former USTs. During excavation of the recovery wells oil saturated soil and oil were observed. The excavation area was backfilled with coarse stone and oil-impacted soil was segregated for off-site disposal. Following installation, the recovery wells were fitted with Abanaki belt skimmers.

*Figure 39(left).* Installation of one of two recovery wells using perforated leaching basin sections.; *Figure 40(right).* Recovery wells fitted with belt skimmers.

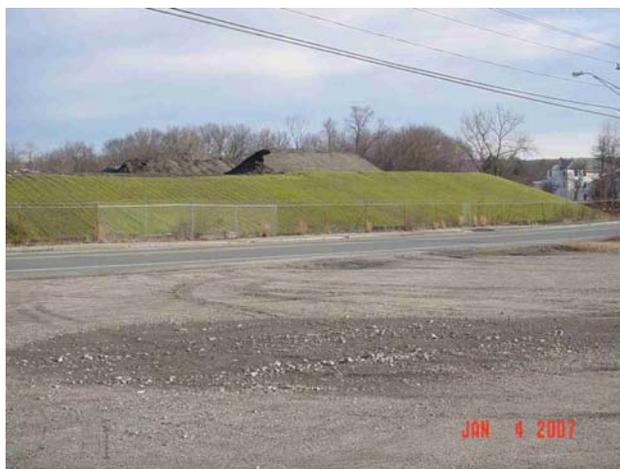
*Figure 41.* View of the site to the northeast across Main Street following application of flowable fill and re-use of offsite soil.
