Thompson Brook Restoration and Aquatic Organism Passage Design

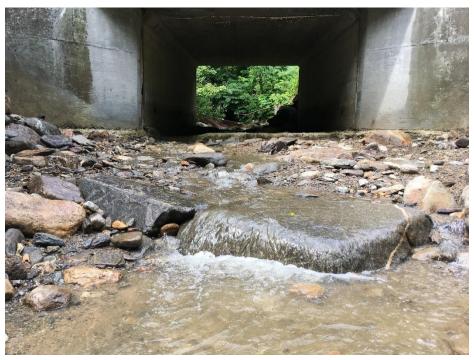
The grade control structure, made of boulders, seen downstream of the NHDOT culvert.

The restoration design plans included the installation of grade controls just downstream of the box culvert structure to raise the channel bed, eliminating the perched condition at the NHDOT culvert outlet and improving AOP. New Hampshire Fish & Game has deemed successful implementation of the project a priority due to a significant brook trout population in the unnamed tributary.

Construction was completed in summer 2019 and oversight was provided by Trout Unlimited and Stone. Construction included washing in fines around grade controls, as well as reshaping a flood channel and existing gravel bar. The contractor matched the existing shape of the channel, while placing roughness boulders throughout the channel bed. In addition, the bank area of the former access road was reshaped using cobble and soil, while the hillside was regraded and stabilized with hay and seed.
