Phase II Environmental Site Assessment, Lynwood Crown Farm

Vermont DEC Brownfields Technical
Assistant Grant
Site-Specific Health and Safety Plan (HASP)
Workplan and Cost Estimate
Phase II ESA (ASTM E1903-11) & Final
Report

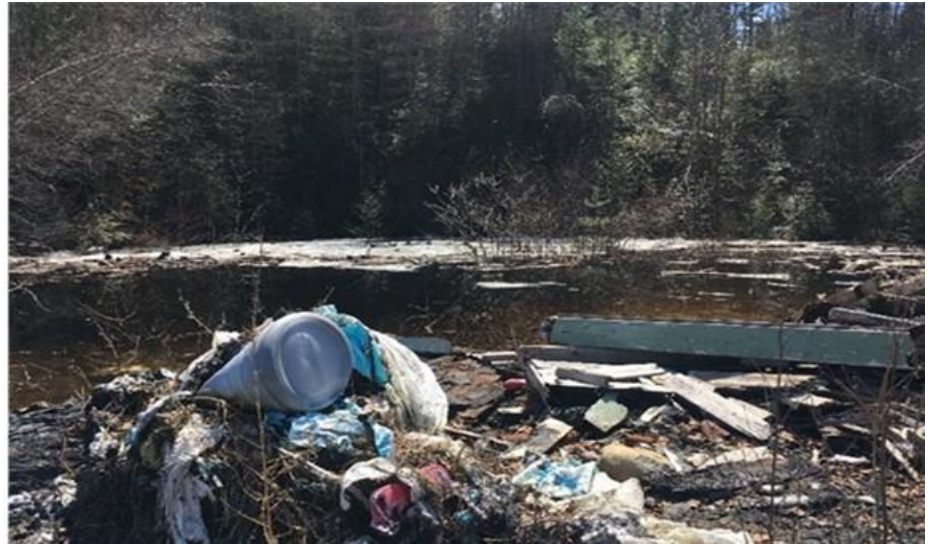
Lynwood Crown farm dump during flood stage of the Clyde River. Dump contents are in direct contact with flood water.

Test pitting activities identified petroleum and hazardous materials within the farm dump. Stone coordinated with Solid Waste Division to determine an appropriate cleanup plan for the farm dump. Assessment of other areas of concern concluded that releases of hazardous materials were limited to petroleum contamination related to an aboveground storage tank (AST).

Next steps include the development of a Corrective Action Plan to address petroleum contaminated soils due to an AST release. A Cleanup Plan for approval by Solid Waste department needs to be prepared and implemented for the farm dump.
